Matthew R. Foti Landscape & Tree Service, Inc.

Client: Town of Lexington | Engineering Division

June 3, 2014

Location: Concord Avenue, Lexington

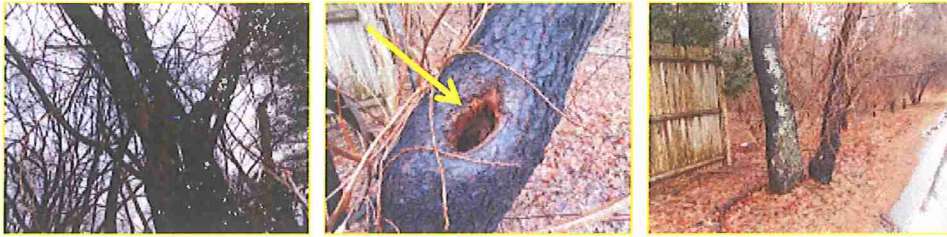
- Double Lead Cherry (14”) – Root flare buried, one leader with broken top, bittersweet climbing trunk, multiple cavities, dead wood and stubs

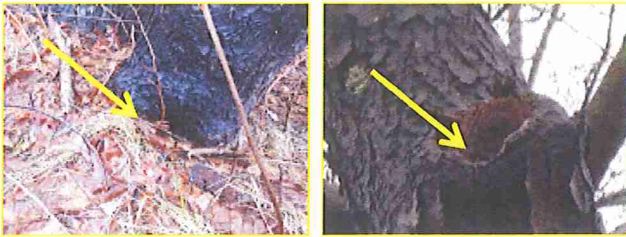
- Cherry (12”) – Root flares buried, top dead, dead wood, stubs and cavities

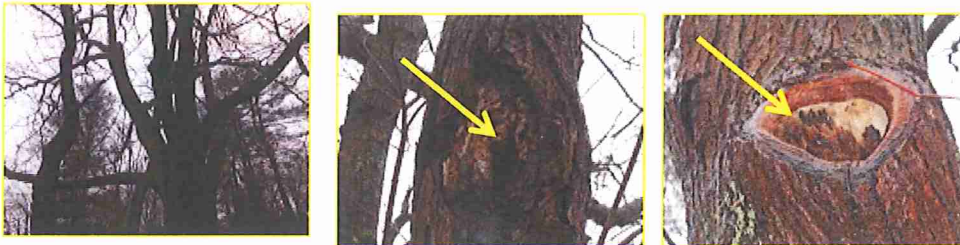
- Maple (14”) – Root flare exposed, contorted stem, cavities both side of stem, dead wood, and stubs

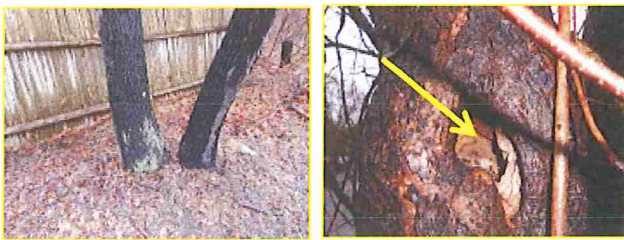
- Double Lead Cherry (12”) – Root flare partially exposed, contorted stem leaning over street, decay in main stem, cavities and dead wood

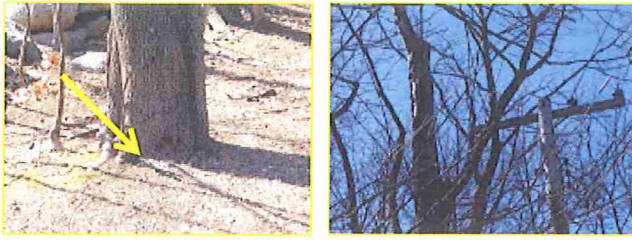
- **#510 Concord Avenue - Maple (18")**
 - Root flare buried.
 - Two main leaders.
 - First lead has broken top
 - Second lead is growing through the primaries

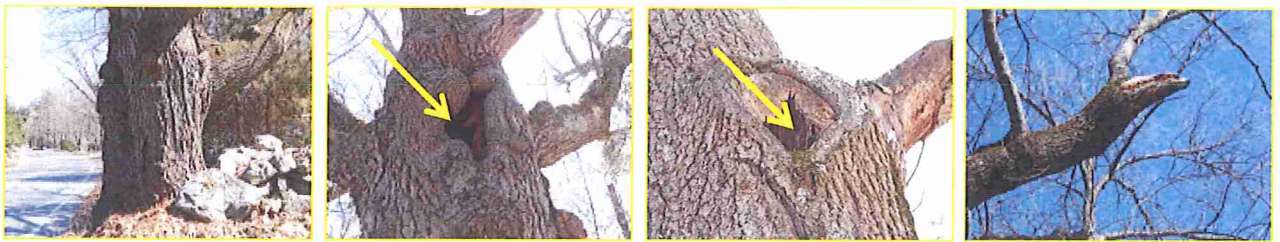
- **#516 Concord Avenue – Oak (55")**
 - No root flare.
 - Large cavity main stem.
 - Decay.
 - Many poor pruning cuts/stubs.

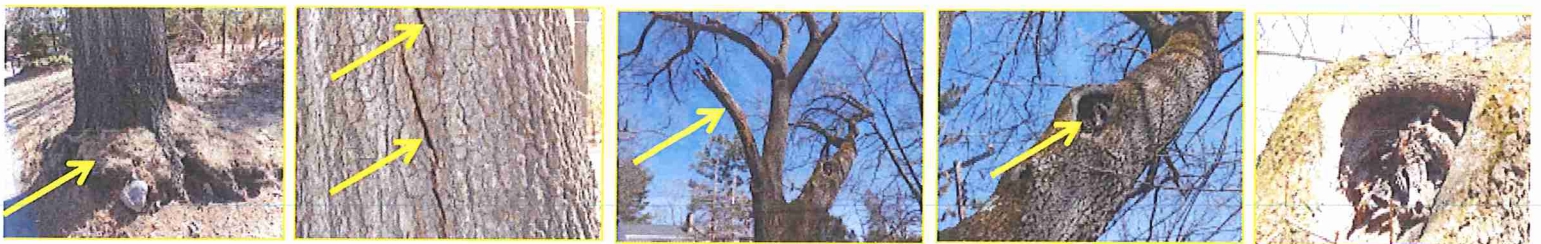
- **#524 Concord Avenue - Oak (42")**
 - Flare compromised, huge vertical stress crack in main stem, surface roots cut on both street and driveway side, large cavity in leader over street. – Tree in very bad shape.
